Navajo Abandoned Uranium Mine

Site Screen Report

Mine Name: Max Huskon No. 1
Mine ID: 546

August 2011

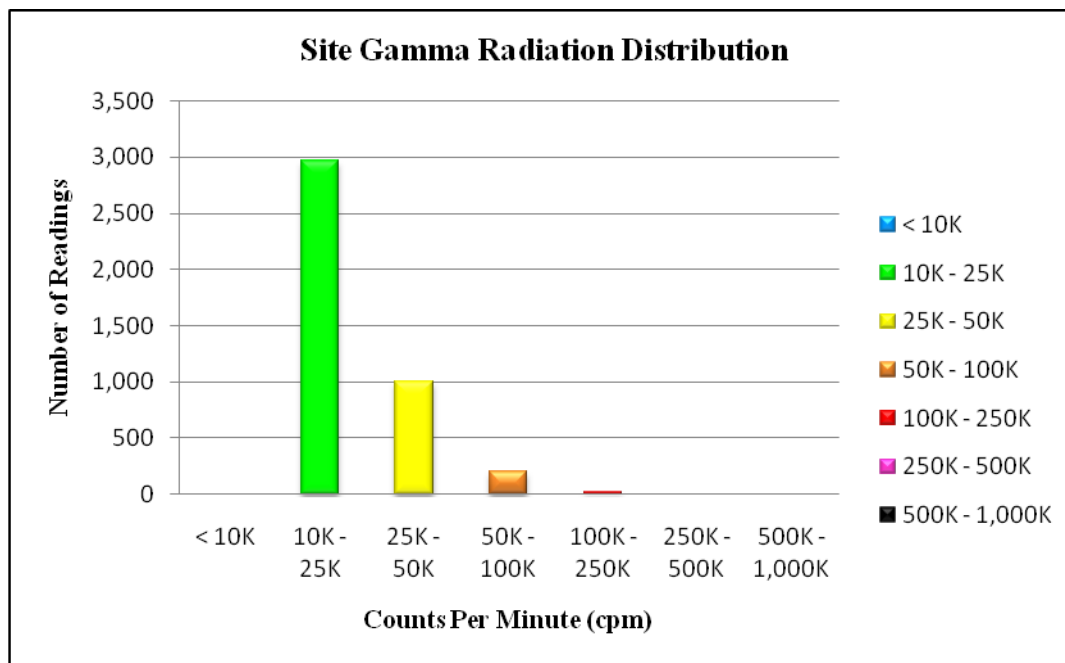
Distribution Chart and Statistics:

Site Gamma Radiation Statistics	
Number of Readings	4,200
Minimum (cpm)	12,944
Maximum (cpm)	152,751
Mean (cpm)	25,646
Median (cpm)	20,990
Standard Deviation	14,236

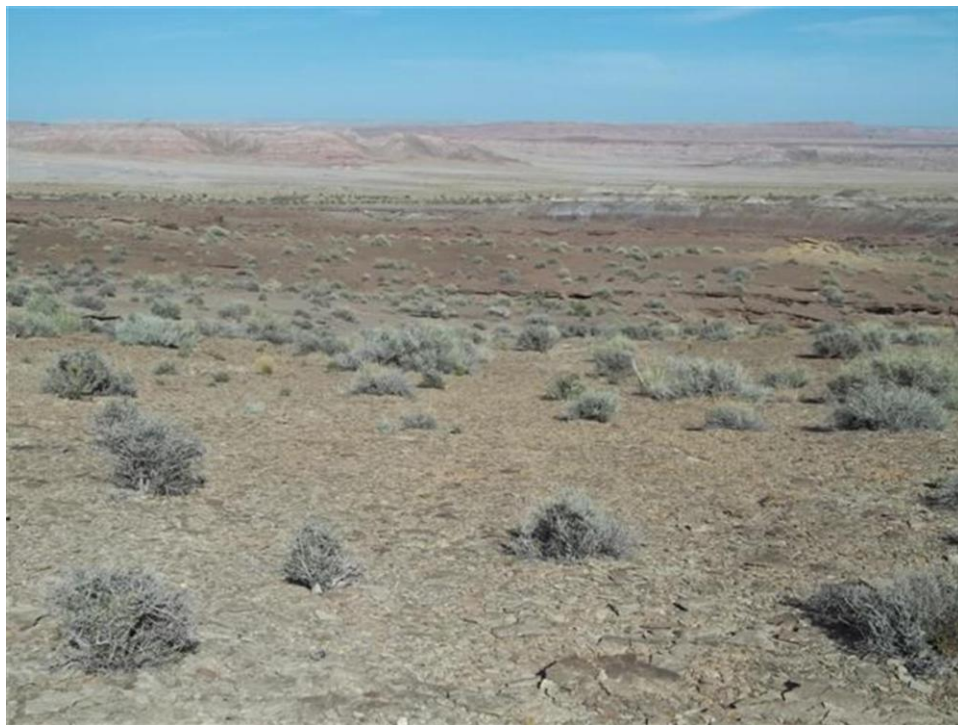
Photo 1: Mine Site #546

4 waste rock piles: Pile 1 - 8'dia x 1.5h; Pile 2 - 6' x 10' x 4'; Pile 3 - 15'dia x 5'h; Pile 4 - 5' x 8' x 3' (piles 2 are 4 may be connected)

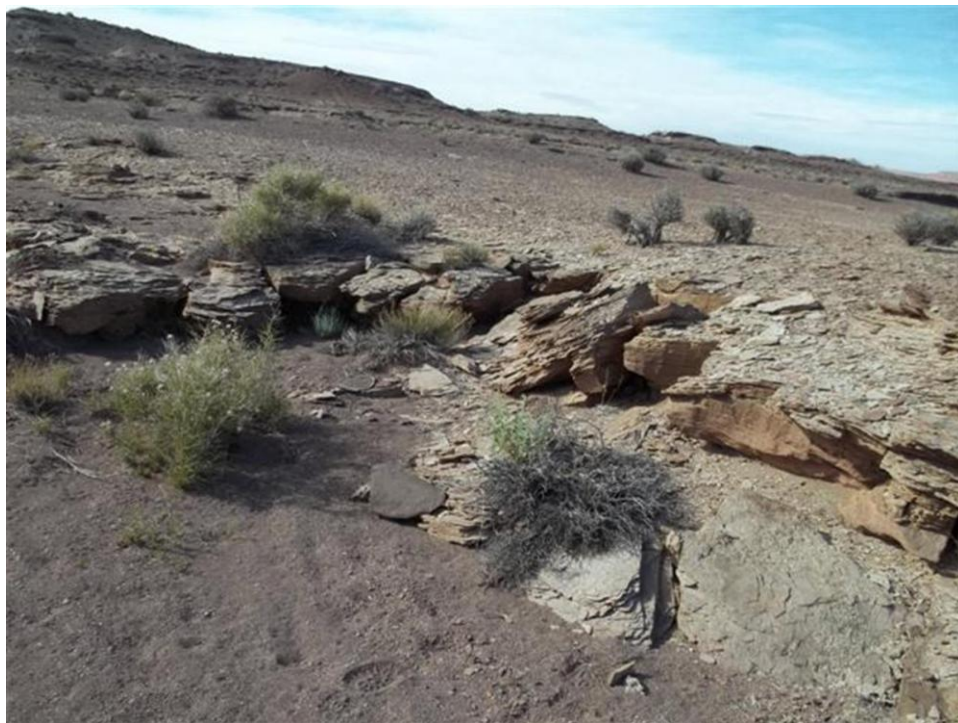
Photo 3: Mine Site #546; Elevated readings

A total of 4,200 gamma radiation measurements were collected from the mine site, ranging from 12,944 cpm to 152,751 cpm. Measurements collected in the vicinity of the waste rock were found at a maximum level of approximately 40,000 cpm. The measurements are represented in Figures 1 and 2.

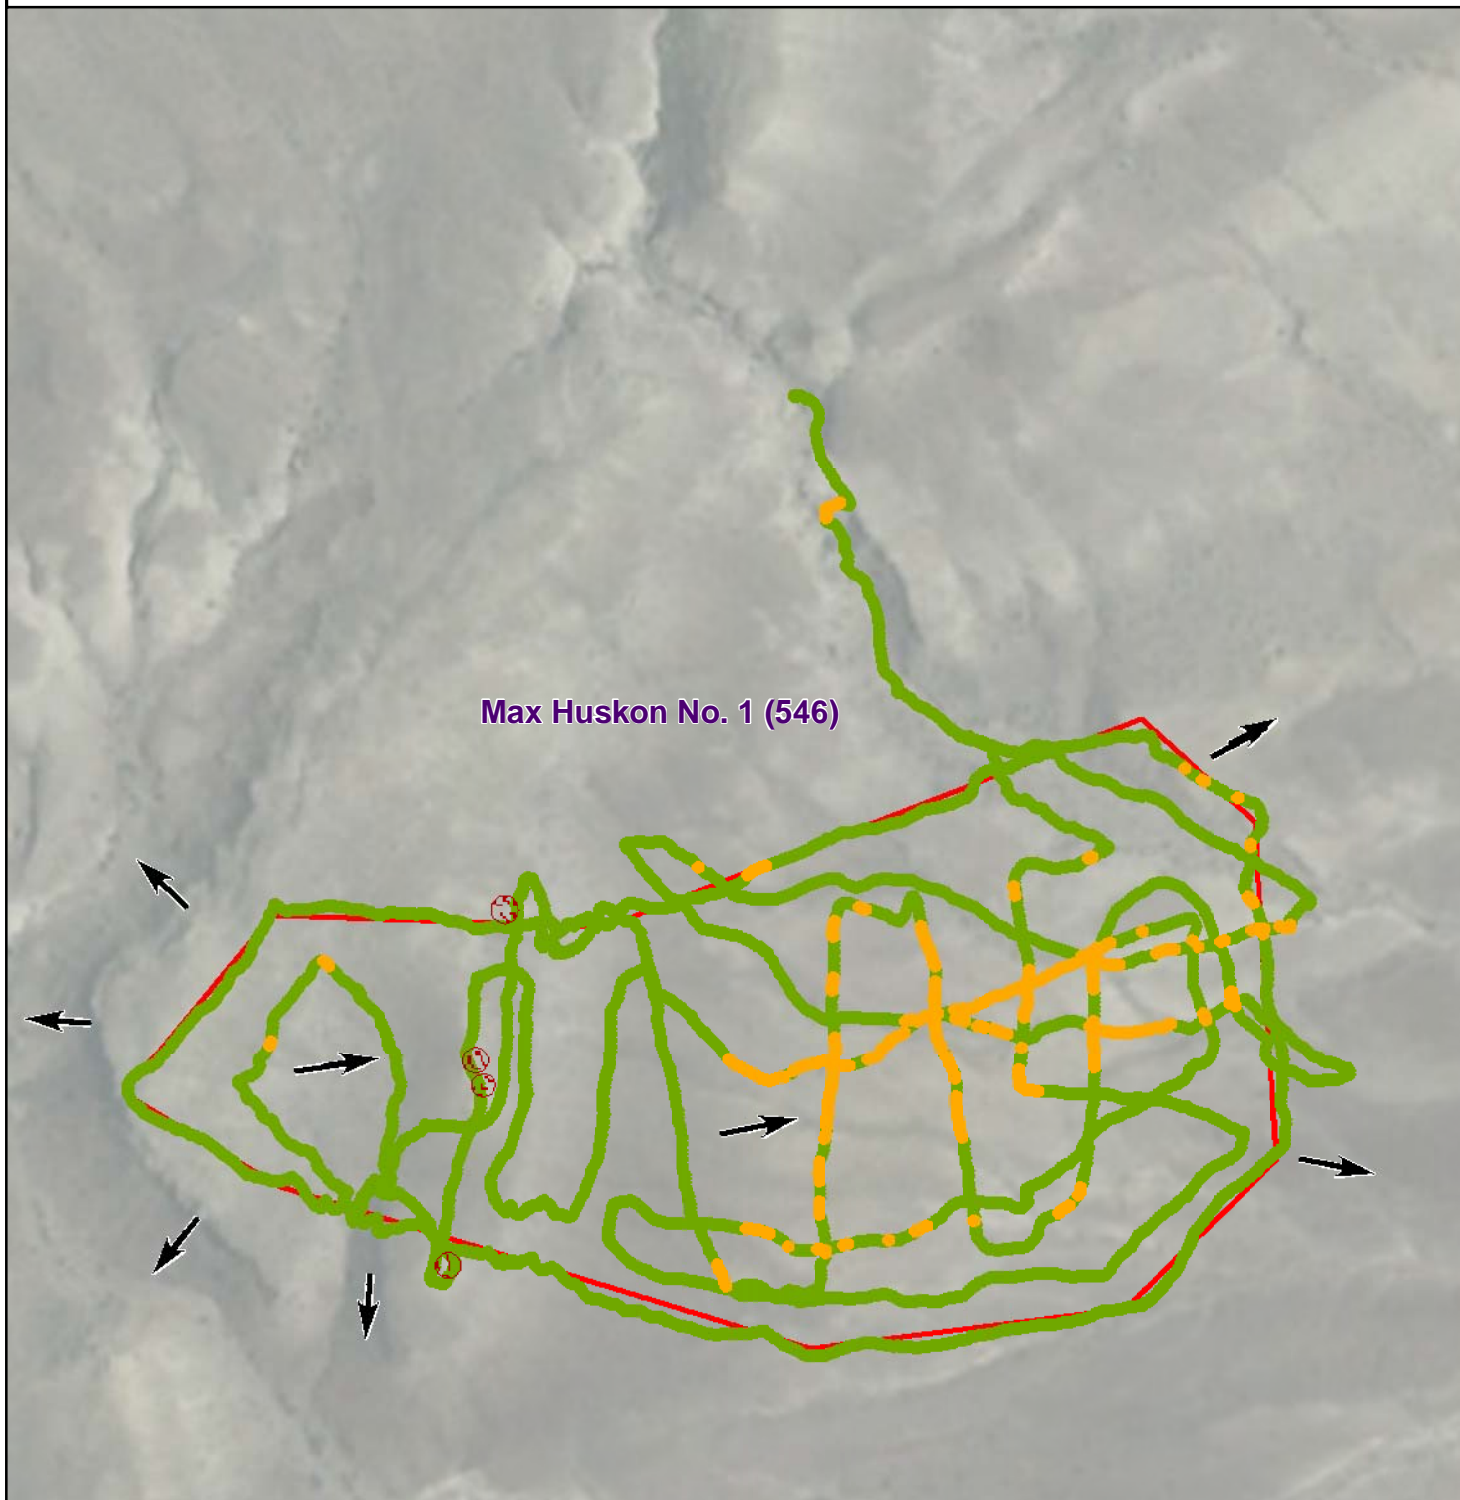
Figure 1 - Gamma Radiation Measurements, Above Two Times Background
Max Huskon No. 1 (546)
Bodaway / Gap Chapter, Navajo Nation

Average background 20,041 cpm

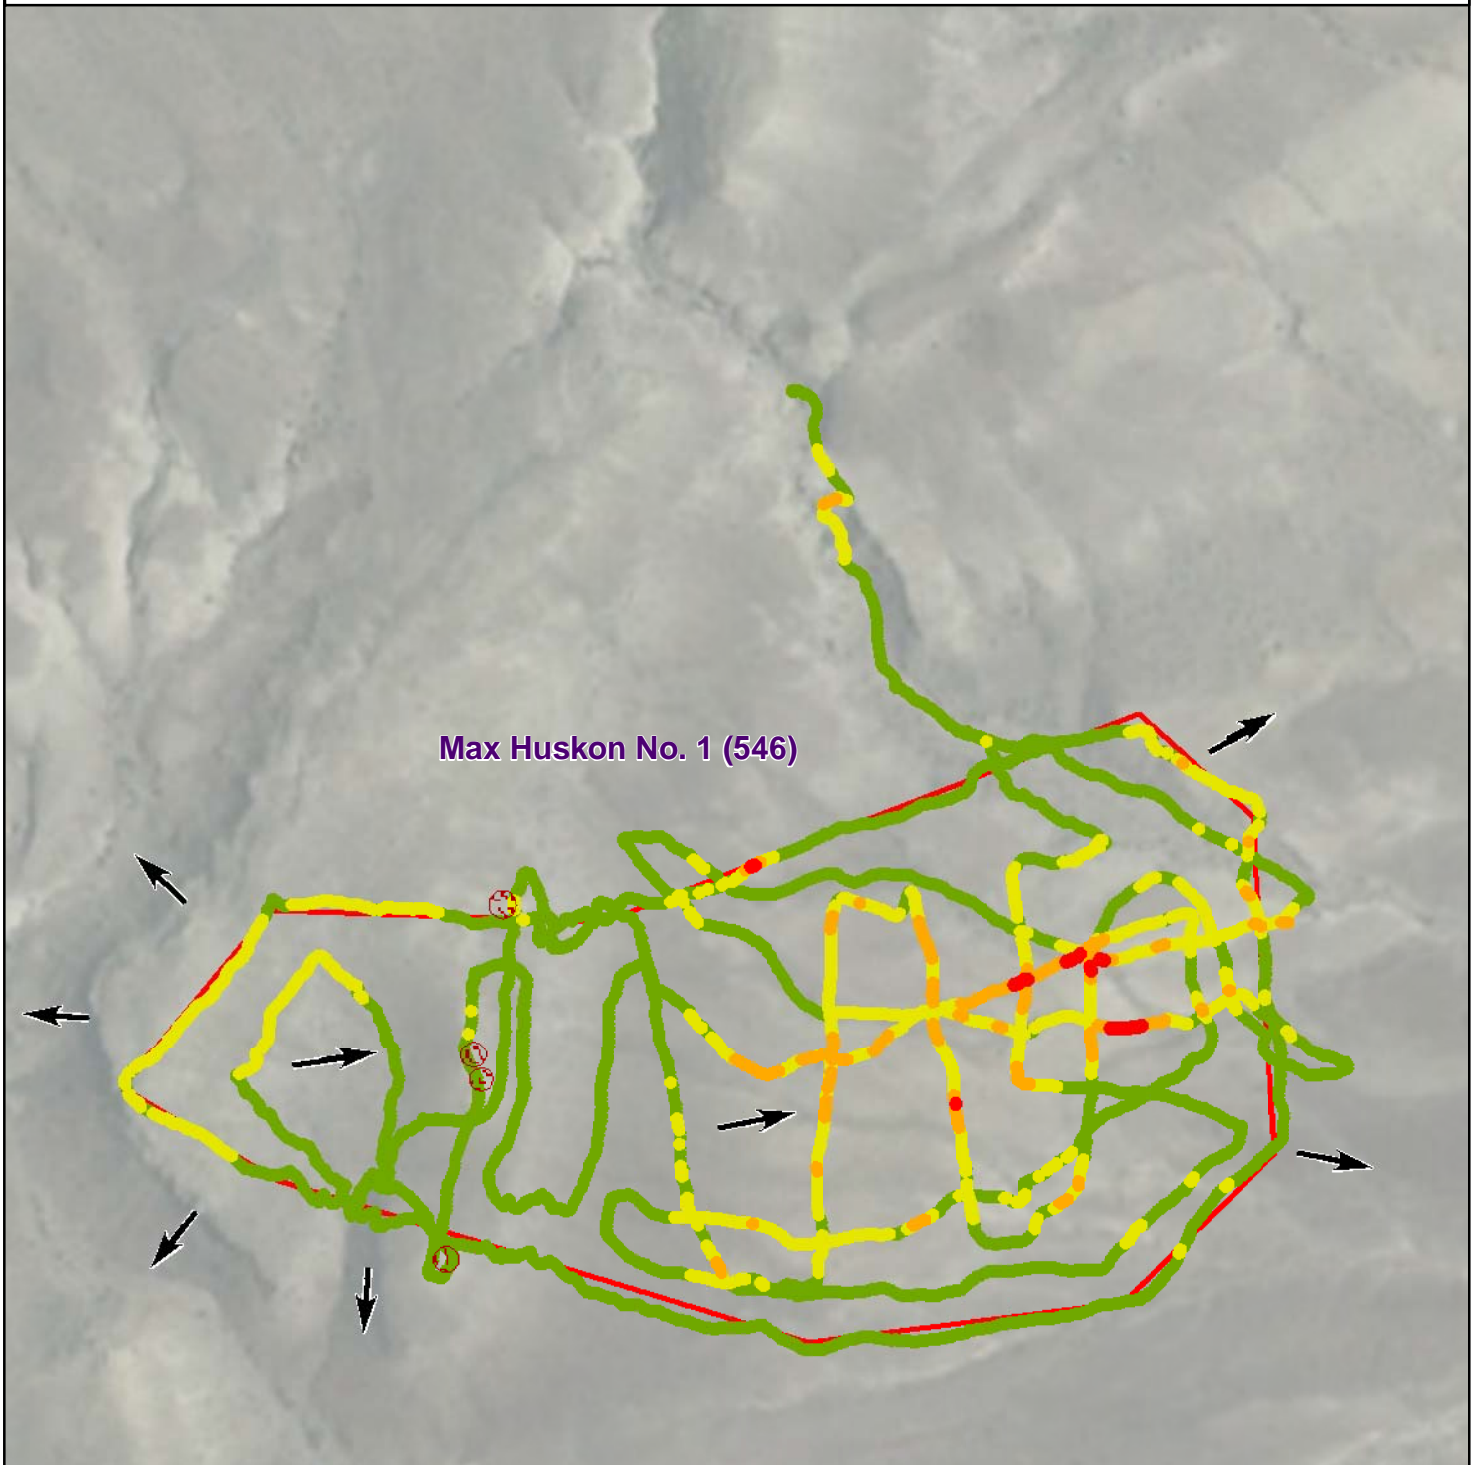
Figure 2 - Gamma Radiation Measurements
Max Huskon No. 1 (546)
Bodaway / Gap Chapter, Navajo Nation

Measured as counts per minute (cpm) Average background 20,041 cpm
